## BUILDING BACK ALBANIA'S CULTURAL HERITAGE FOR THE FUTURE

### THE MONASTERY CHURCH OF RUBIK, MIRDITË, ALBANIA

#### EU4CULTURE PROGRAMME

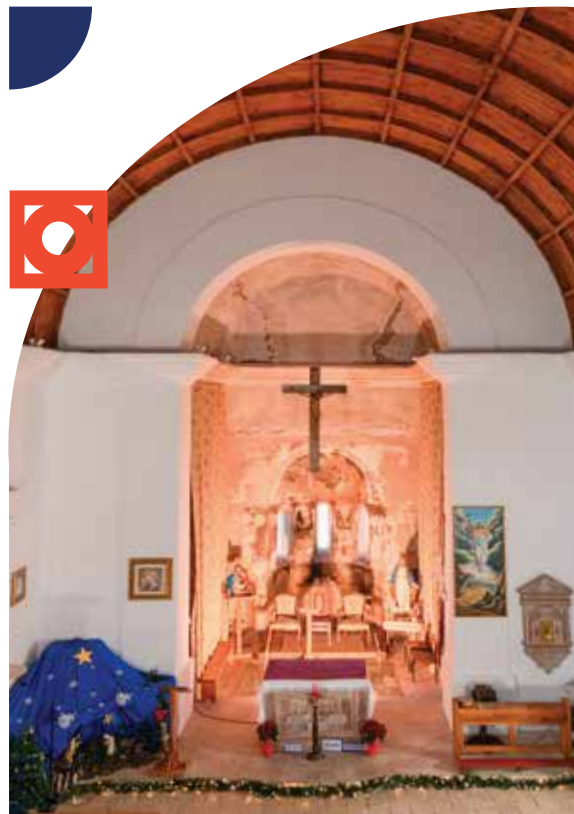
The Monastery Church in Rubik rises on a steep cliff by the river Fan near Rubik. It looks as if it was sculpted on stone. The Church suffered damage after the earthquake. The roof started to leak and many cracks were observed on its plastered facade.

waterproof layers as well as a new gutter system. The facade which was the most delicate part of the building was analysed in detail. The outcome of the analysis was that the most recent plaster was cement based. Initial cracks were allowing moisture to enter, and due to the non permeability of cement, the moisture would stay trapped and would cause further damage resulting in separation of the plaster from the stone wall. If left any longer, the facade would have collapsed.

After careful analysis of historical evidence, it was decided to remove the inappropriate plaster and leave the stone wall exposed. This became especially important in the section of the apse, where a 13th century alternating stone structure was revealed. The alternation in between tuff and lime stone in the masonry structure creates an esthetically pleasing and a very unique outlook of the apse compared to other Churches of a similar period in Albania. Furthermore and in the interior, a necessary emergency consolidation of the remains of the 13th century wall paintings were conducted as well as the upgrade of the electrical installations and lighting creating a more comfortable atmosphere inside.

The works were concluded with repair of the drainage system and the pavement around the Church, including the new lighting stretching down the hill to the main entrance gate.
